ECBC-TR-661

EFFECTS OF VAPORIZED DECONTAMINATION SYSTEMS ON SELECTED BUILDING INTERIOR MATERIALS: VAPORIZED HYDROGEN PEROXIDE

January 2009

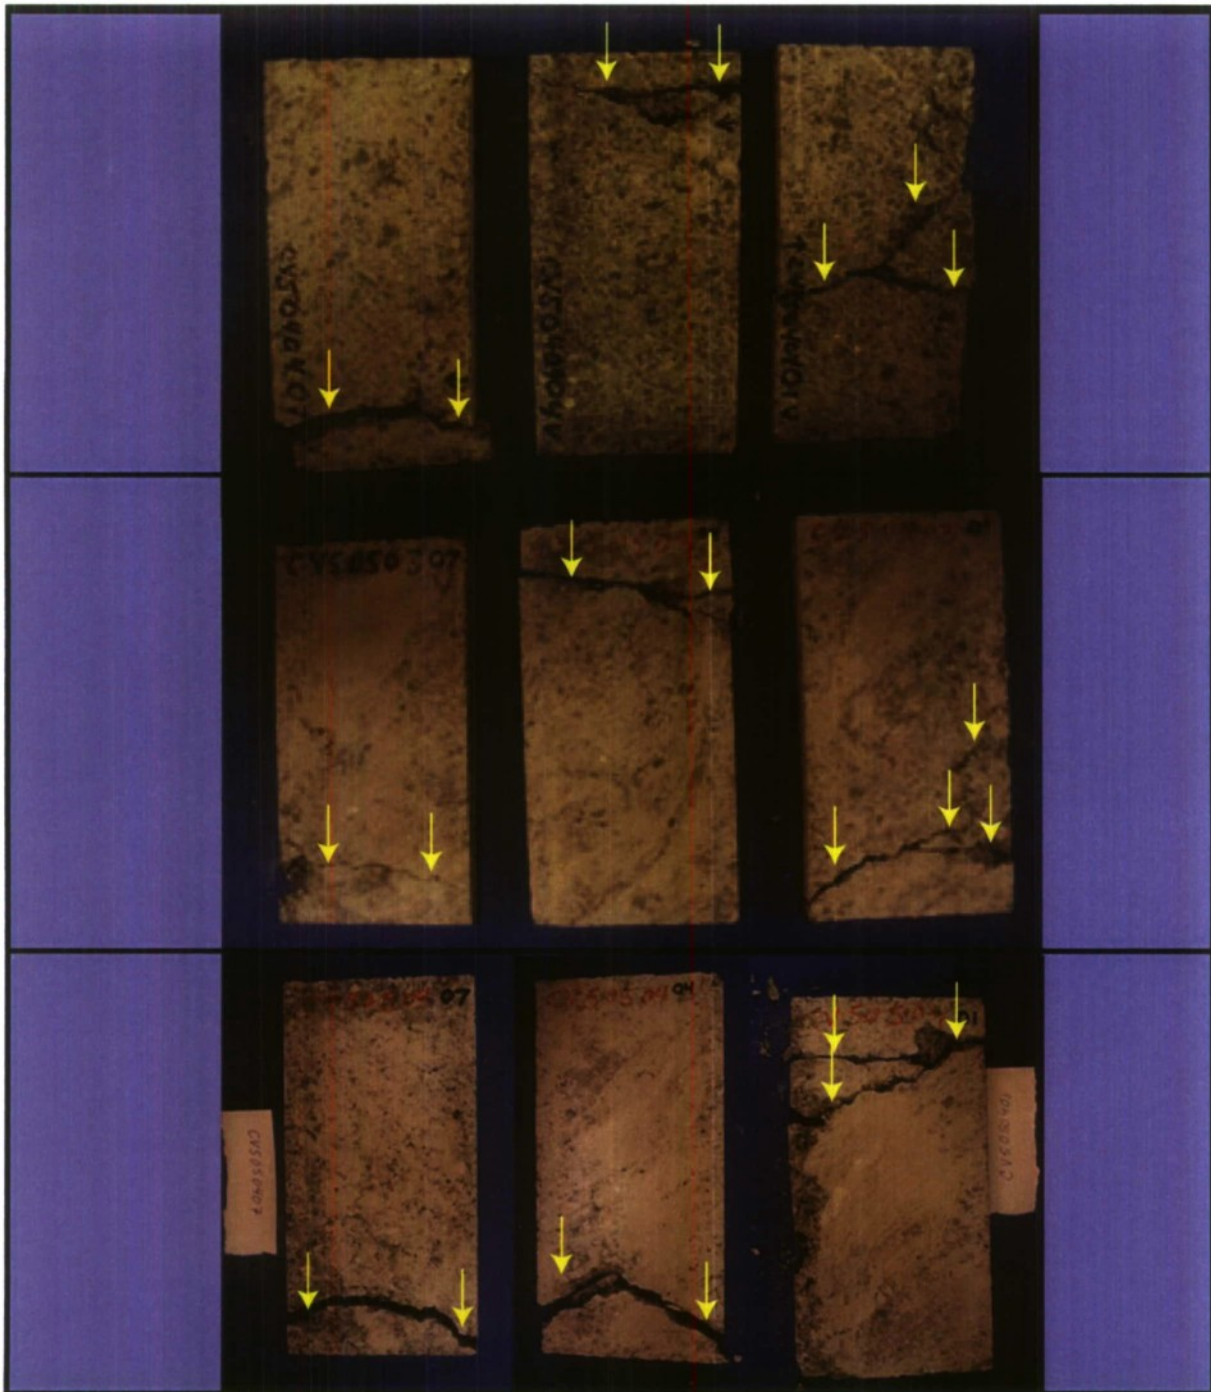
Concrete cinder block coupon location of break: VHP 250 ppm set.
